# Fretting and Corrosion of Dual Mobility Hip Metal Liners: Role of Design, Microstructure, and Malseating

Deborah J. Hall, E. Bailey Terhune, Joseph Serino, Denis Nam, Joshua J. Jacobs, Craig J. Della Valle, Robin Pourzal  
Department of Orthopedic Surgery, Rush University Medical Center, Chicago, IL

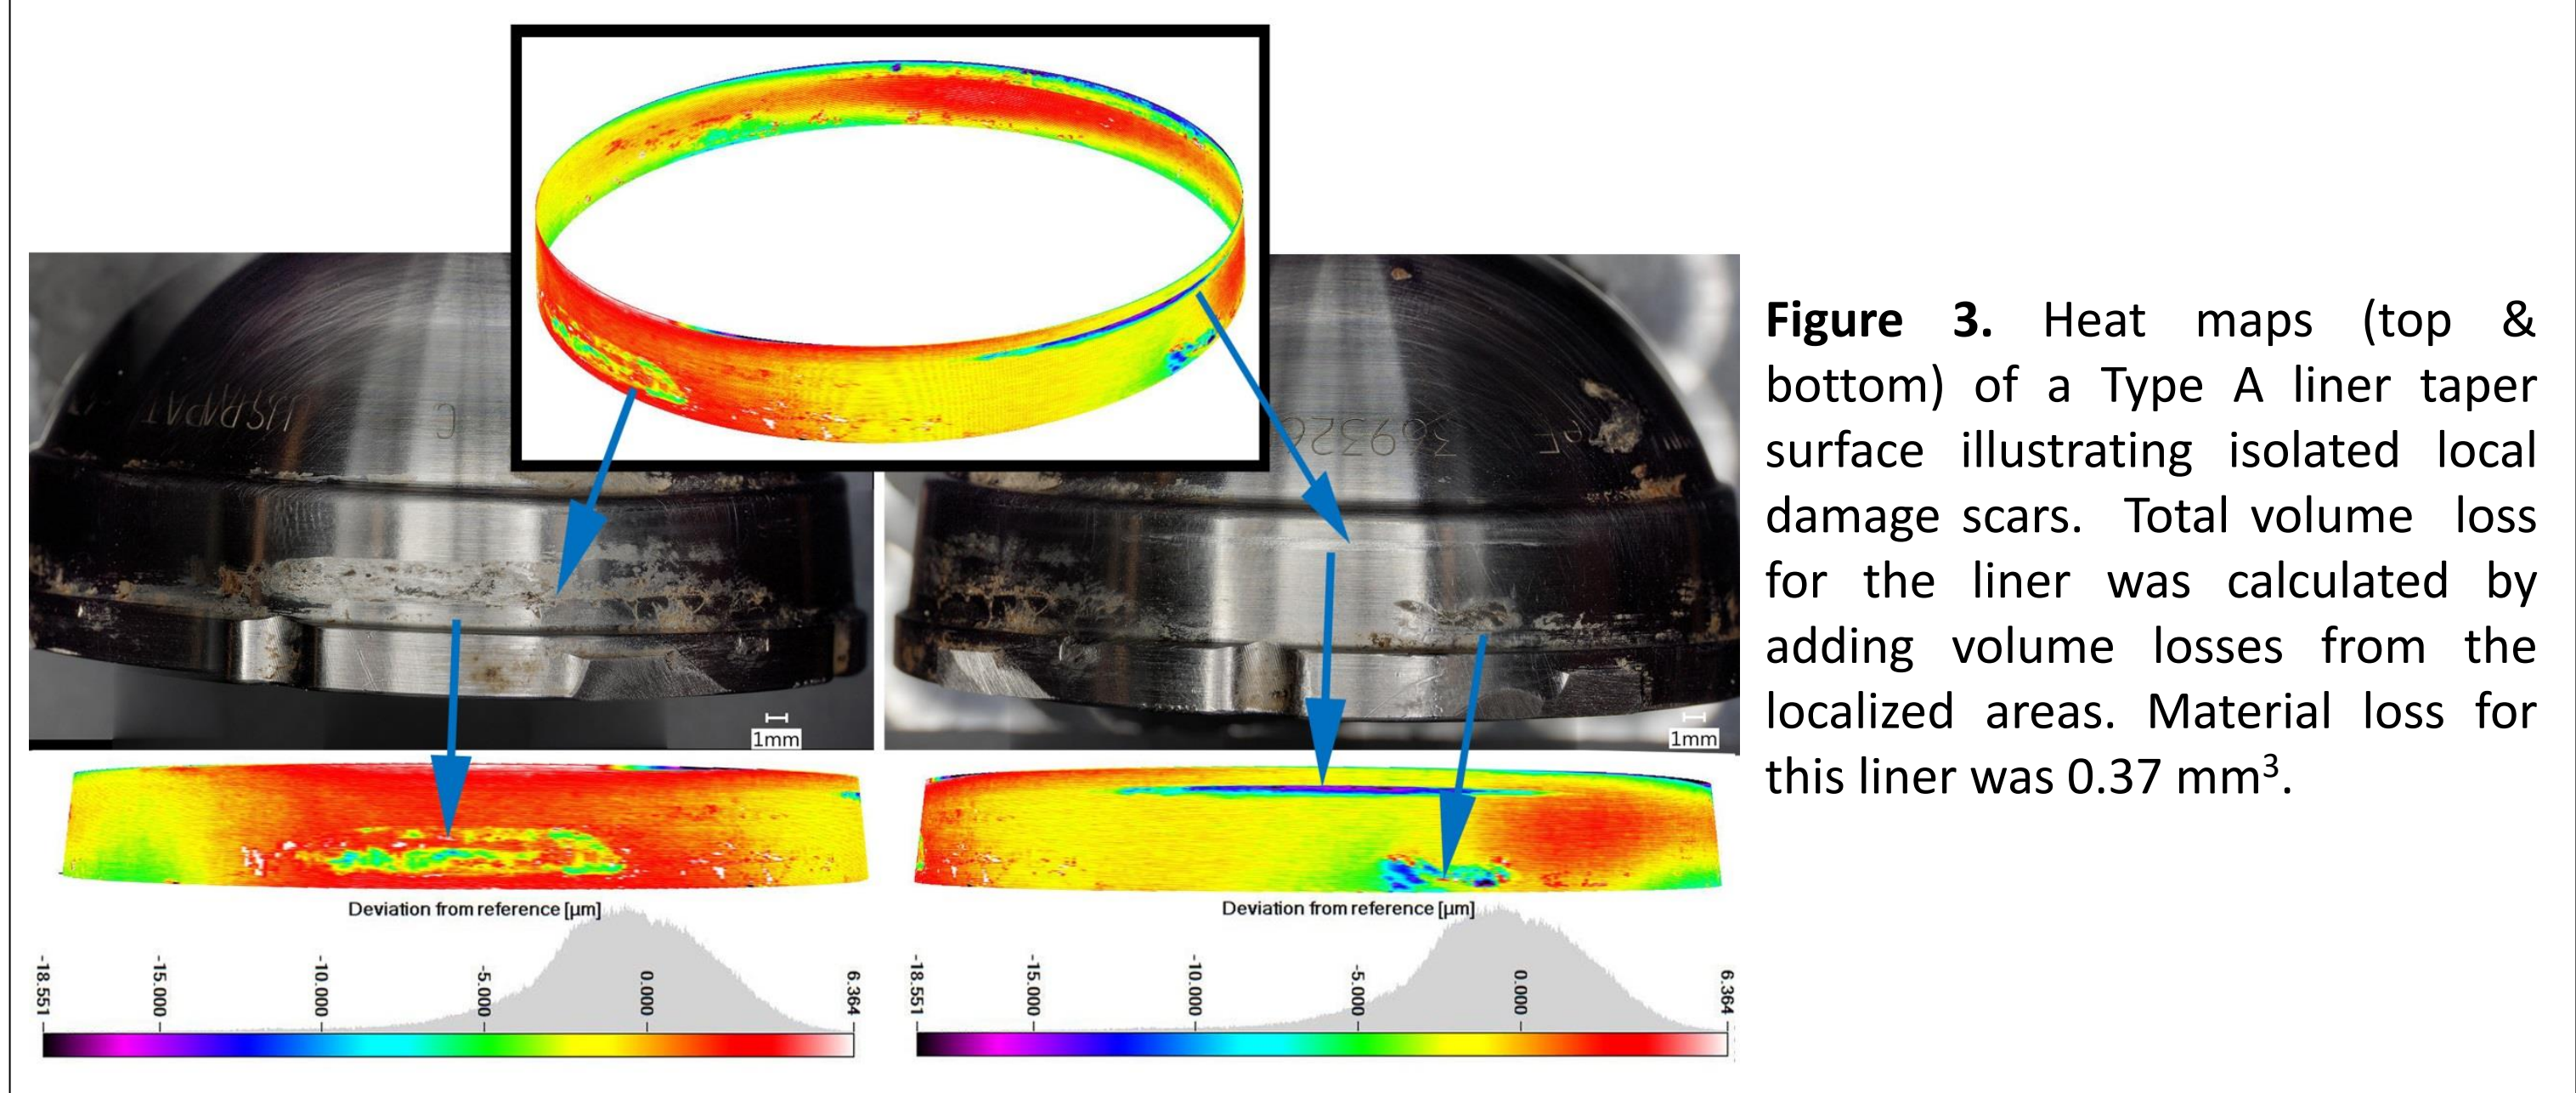
- Exhibited symmetric out-of-roundness (OOR)** that appeared to originate from the machining process (e.g., clamping tool) (Fig 2)
- Local damage scars were isolated, local volume was computed, and loss from local scars was added up for a total volume loss determination (Fig 3)
- Liner A volumetric material loss at the backside occurred in 4 cases (3 with severe and 1 with moderate mGS) with an average material loss of **0.39 mm<sup>3</sup> ± 0.22** and maximum liner penetration of **10.04 µm ± 6.77**
- Damage features on all liners of type A were consistent with fretting and fretting corrosion (Fig 4)
- One case additionally exhibited chemical etching in areas that were not in contact with the acetabular shell due to OOR
- Five liners were malseated**, including 3 cases with severe mGS with measurable volumetric loss and 2 cases with only mild damage

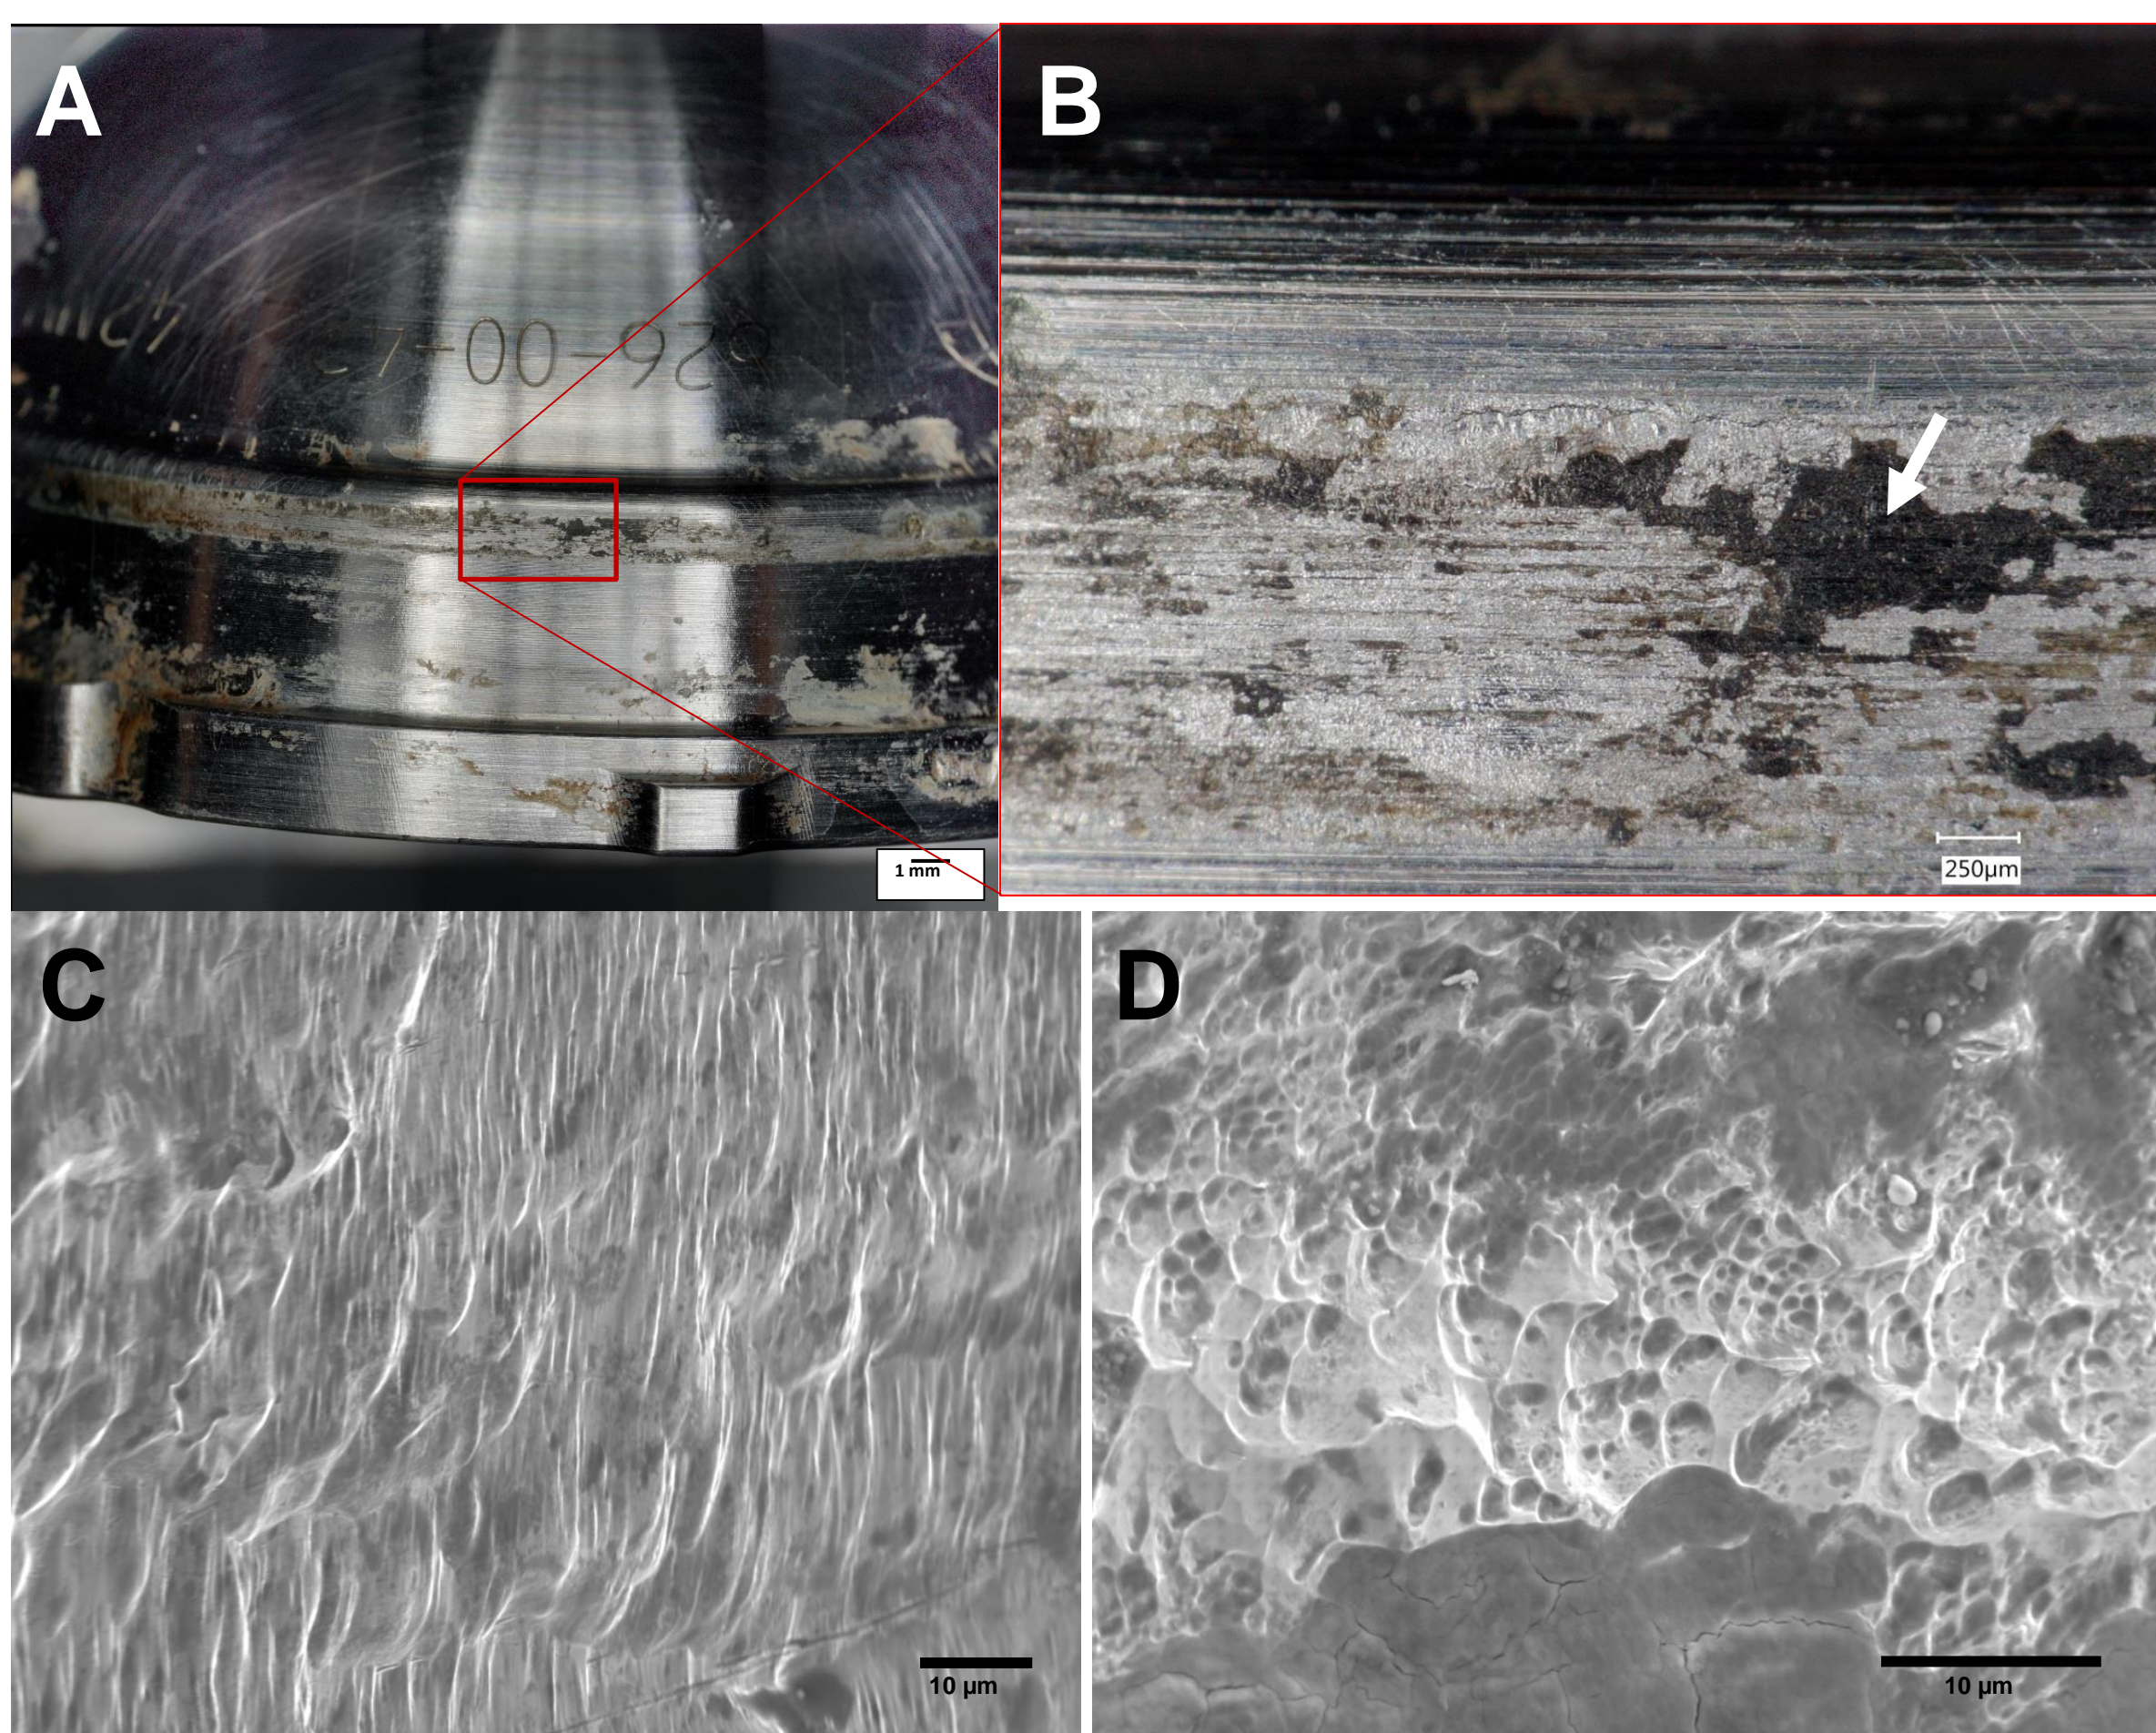
**Figure 4.** A: Type A liner with severe damage. B: Light microscopy image of damaged area (inset A). The deposits on the liner (arrow) were identified by EDS as chromium oxides. C&D: SEM micrographs of the area in B showing fretting corrosion damage (X1300, X2500).
