# Role of CoCrMo Alloy Banding on the Corrosion Behavior of Postmortem Retrieved Femoral Heads

Poster 1731

The Robbins and Jacobs
Family Biocompatibility and
Implant Pathology
Laboratory

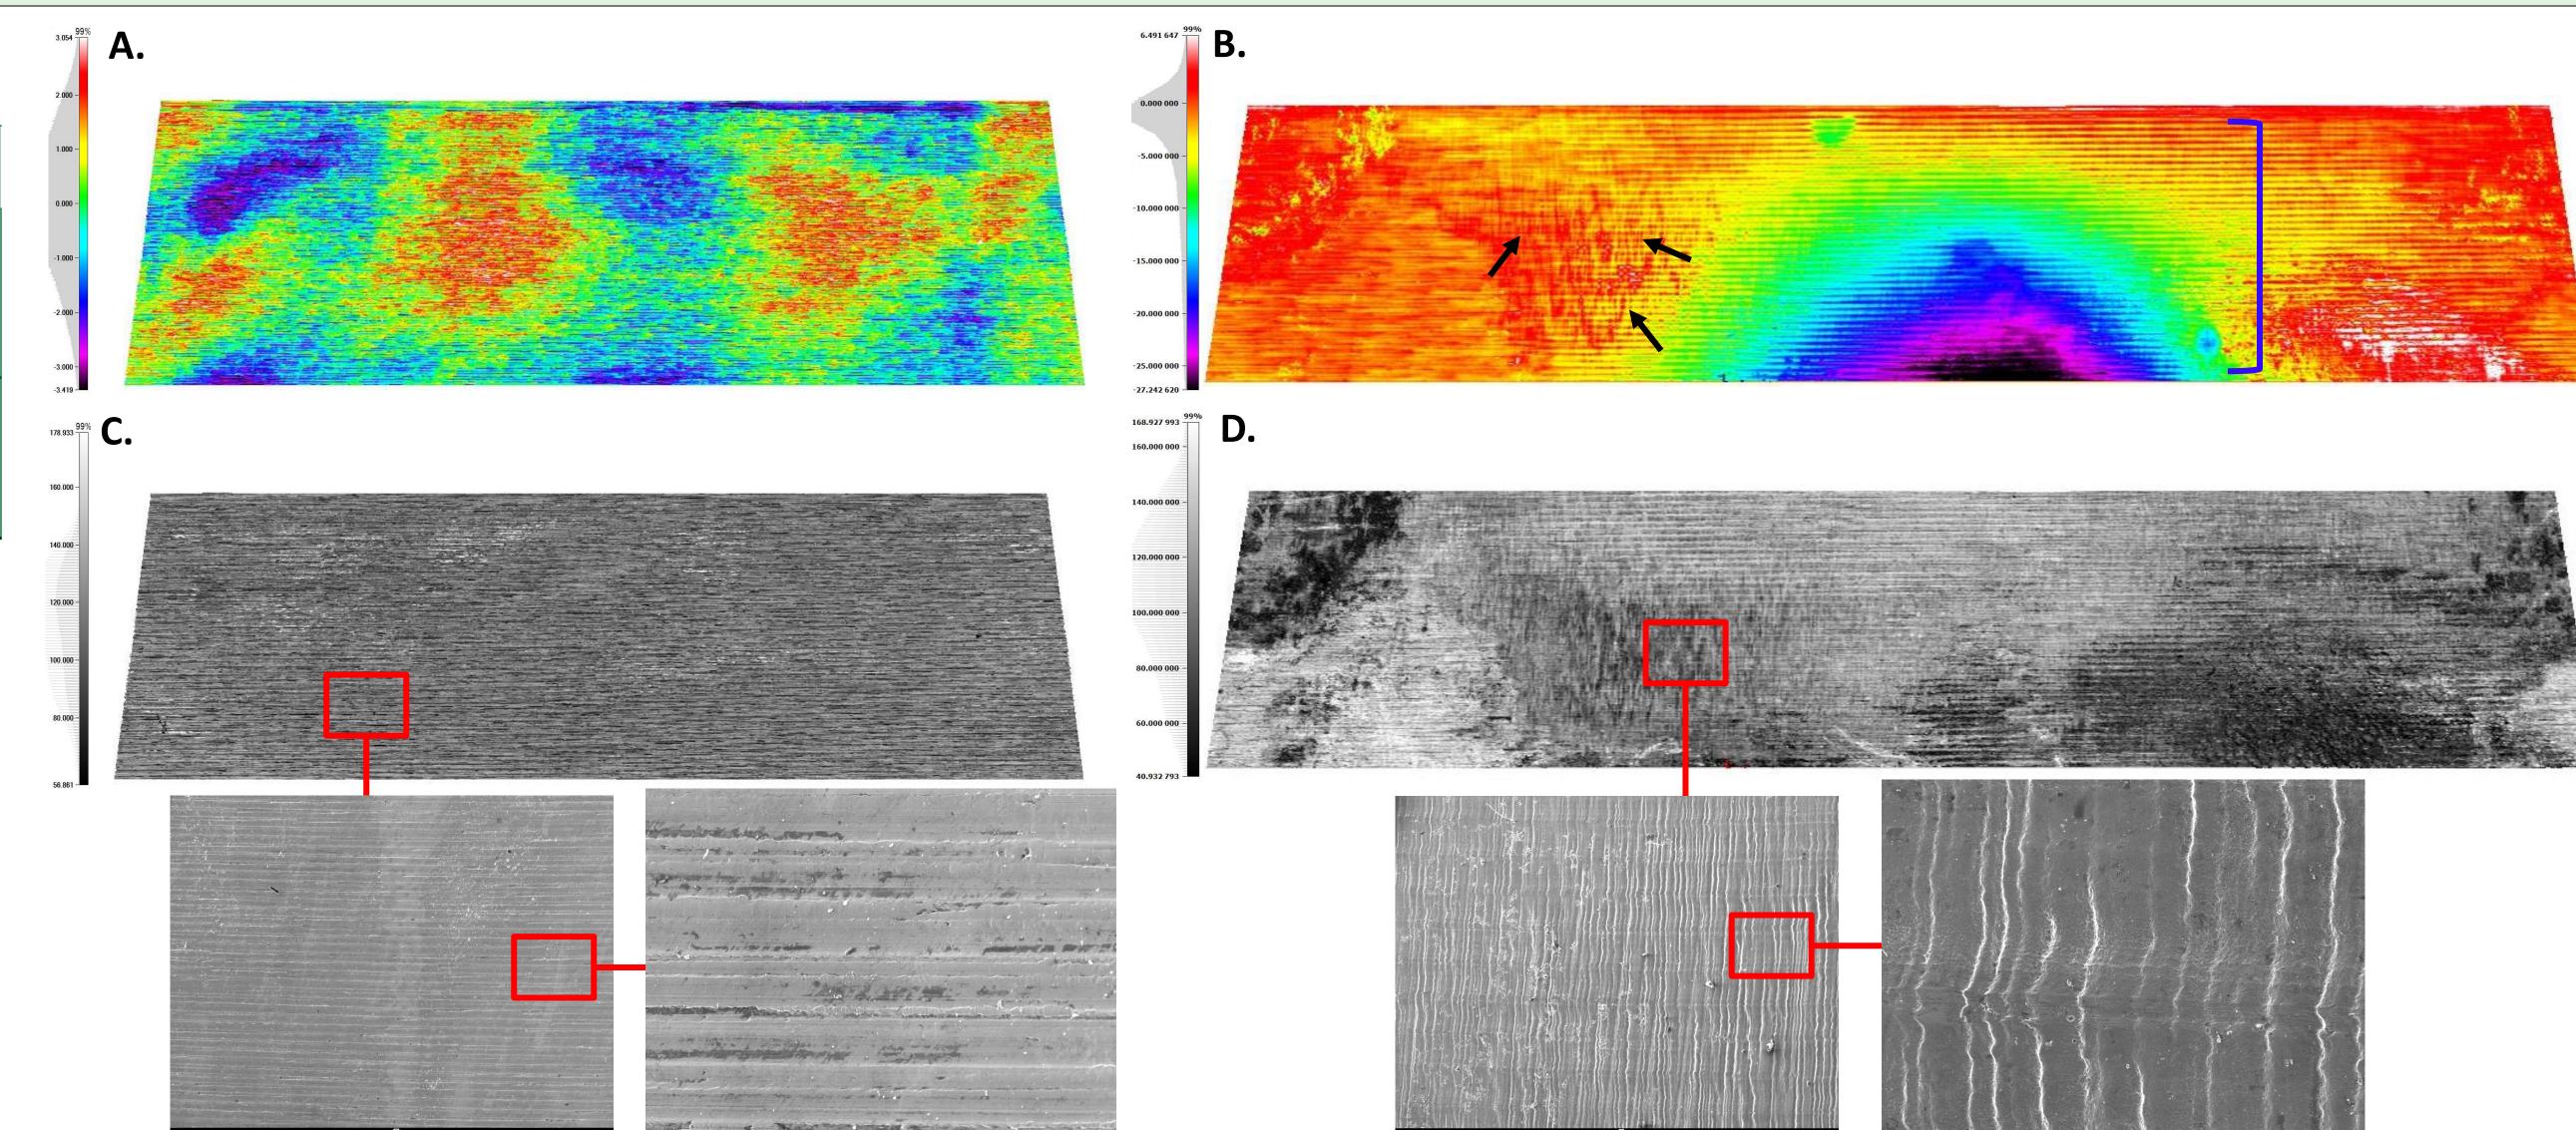
Figure 3: Heat maps (top) and intensity maps (middle) of undamaged (A & C) and damaged (B & D) PMR femoral head tapers. The undamaged head taper shows negligible damage, while the damaged head taper exhibits imprinting (blue bracket) and column damage (black arrows). Scanning electron microscopy images (bottom) of undamaged and damaged surfaces show original head taper topography and chemically induced column damage, respectively.
