# Fretting and Corrosion of Dual Mobility Hip Metal Liners: Role of Design, Microstructure, and Malseating

Deborah J. Hall, E. Bailey Terhune, Joseph Serino, Denis Nam, Joshua J. Jacobs, Craig J. Della Valle, Robin Pourzal  
Department of Orthopedic Surgery, Rush University Medical Center, Chicago, IL

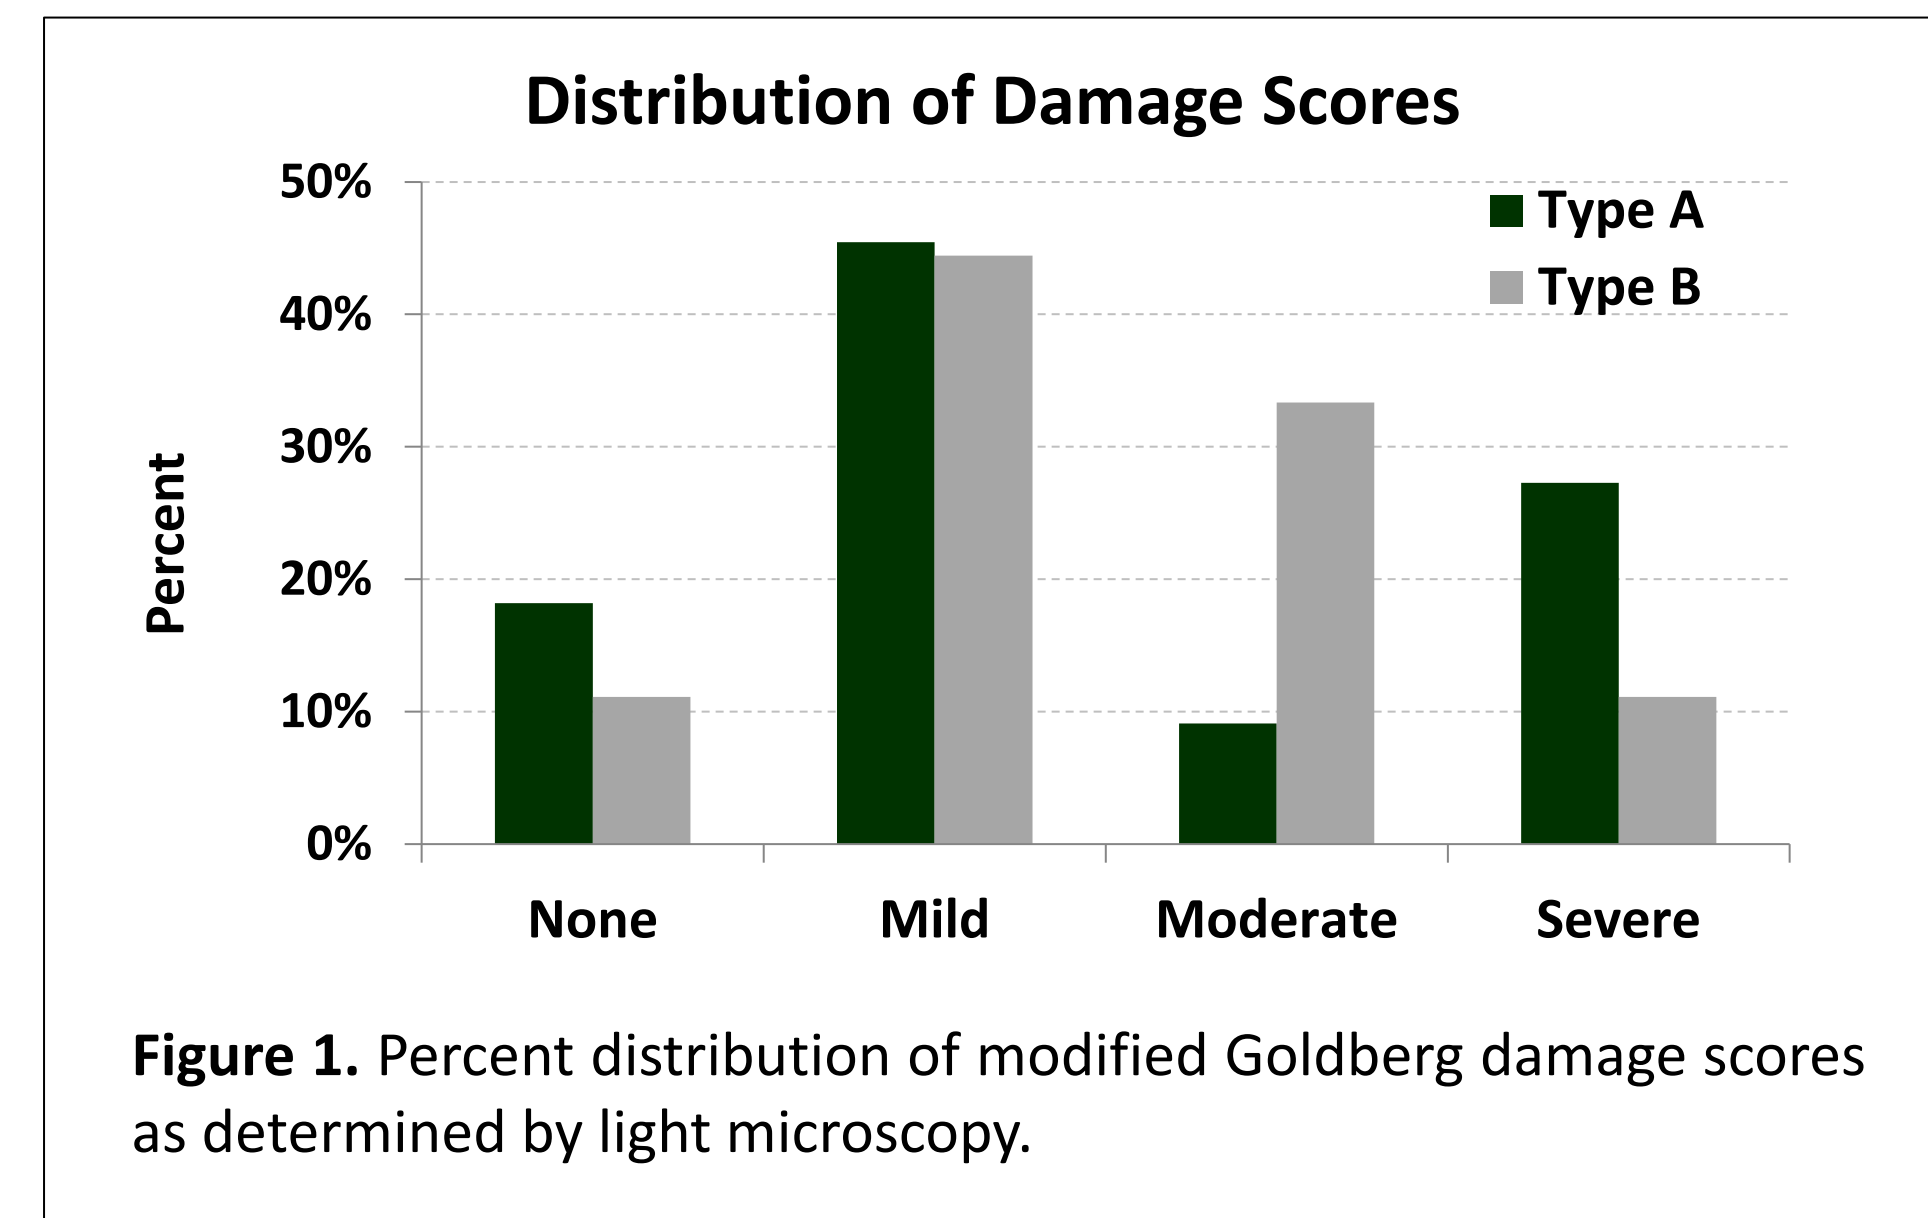
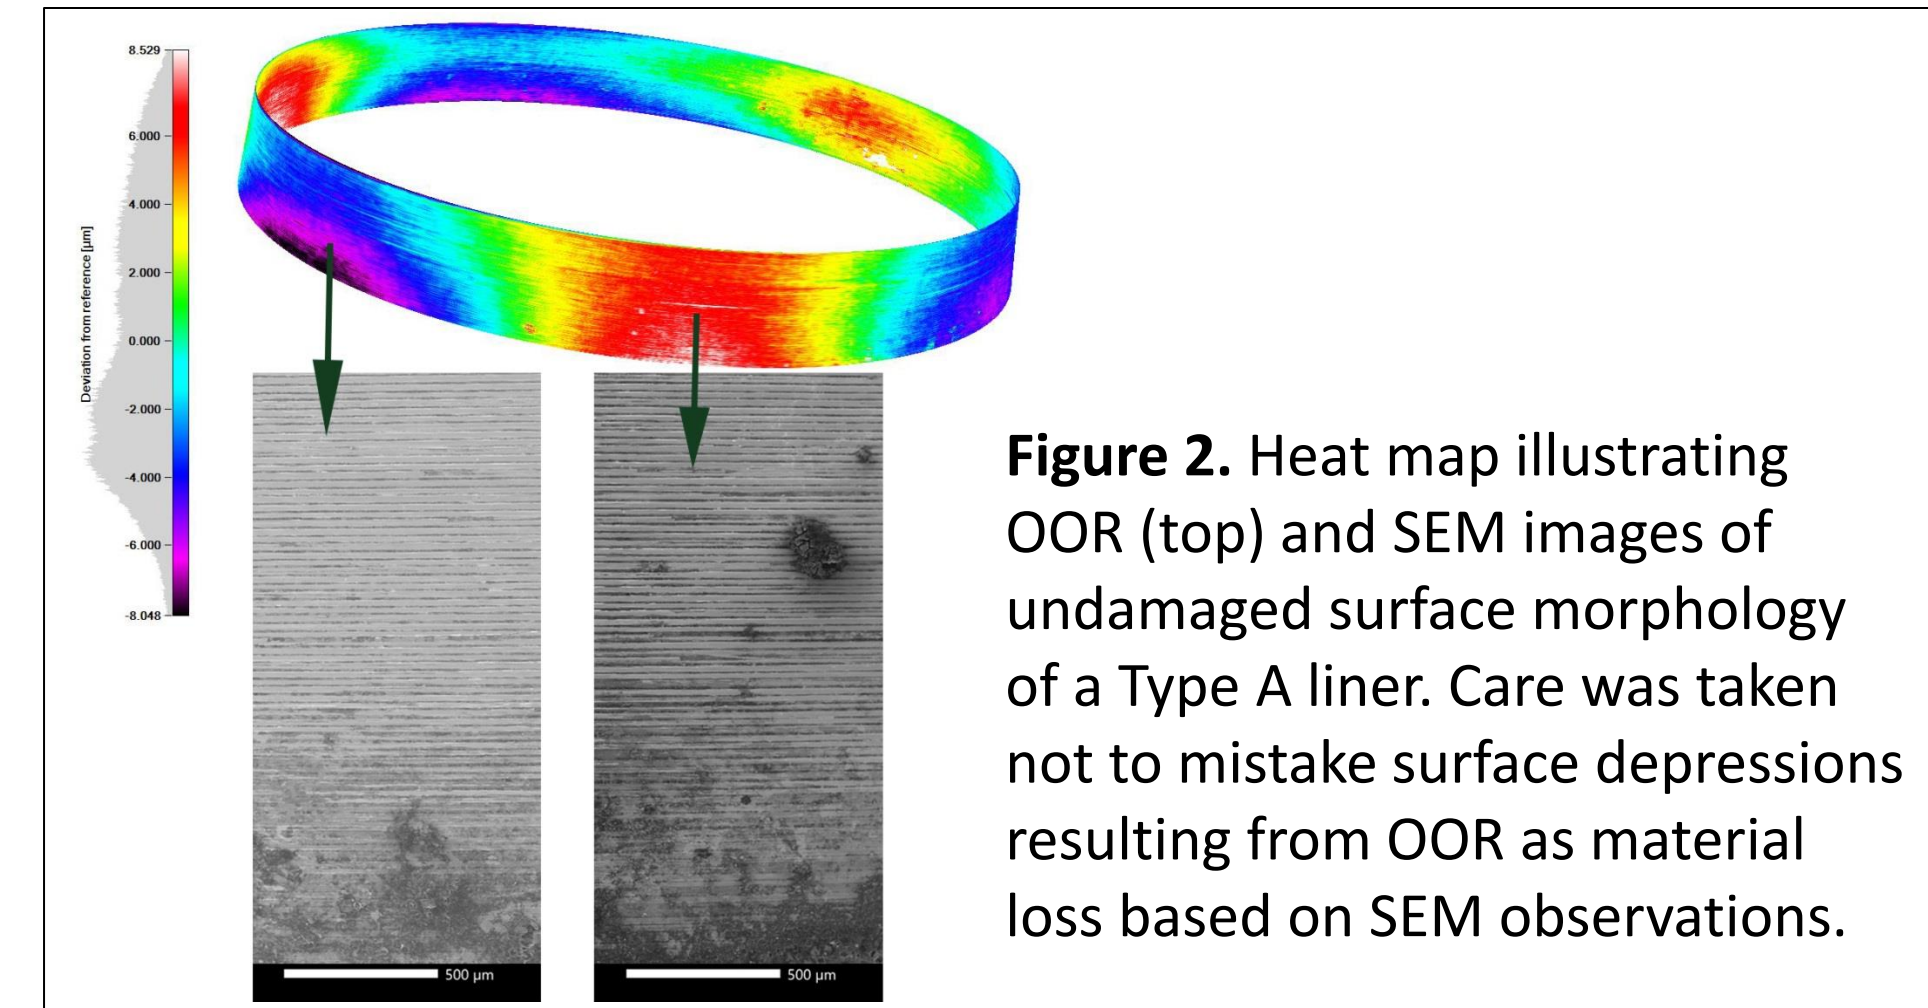
Implant Features	Type A	Type B
Wall Thickness	4.1 mm	3.1 mm
Microstructure	Wrought CoCrMo	Cast CoCrMo with heat treatment after casting
Final Manufacturing Step	Machining	Roughened surface finish indicative of sand blasting

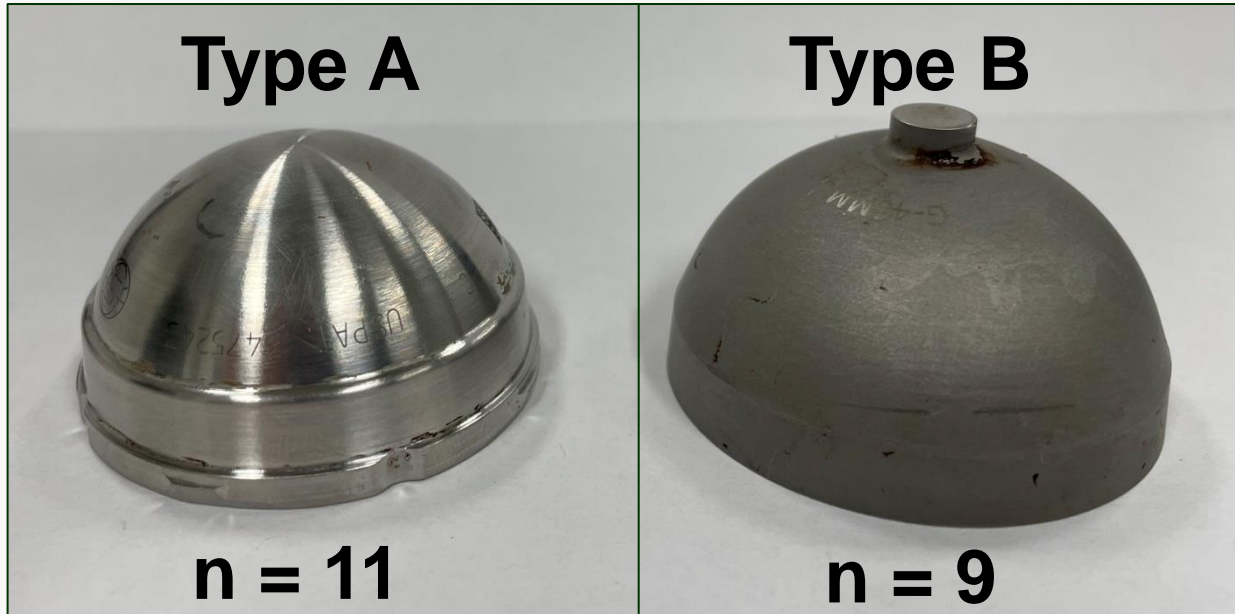
Type A n = 11      Type B n = 9
